# Manhole Inspection Summary

Manhole # S13EE\_033MH

**Location** Address: **REAR OF 1407 POPLAR GROVE** Cross Street: **BELMONT AVE**

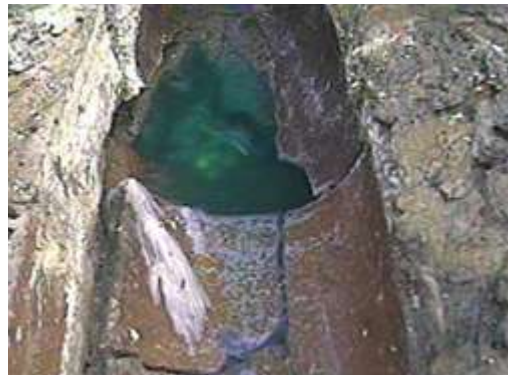
Defect 1

**Channel** Material: **Clay** ☐ Parged  
Channel Exposure: **Fully Open** Junc Dist: **0** nearest .5 ft. Azimuth:  
Condition: ☐ Sound ☒ **Cracked** ☐ Root Intrusion ☒ **Deteriorated** ☒ **Leaks** ☐ Debris

BREAK IN CHANNEL-LEAKS AND  
CRACKS

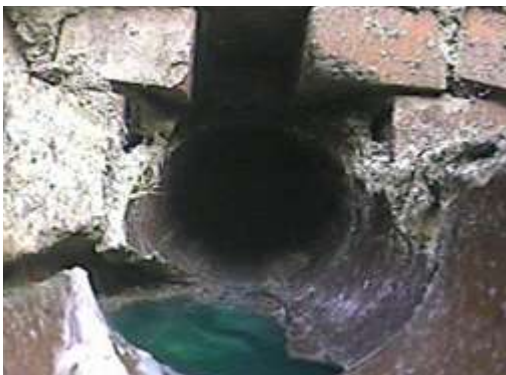
Defect 2

PIPE SEAL BROKEN

Pipe Height: (in.) Direct  
Pipe Material: **Clay** ☐ Pipe Lined  
Invert Depth: **2.48** (ft.) Flow Characteristics: **Slow**  
Deposits: ☒ None ☐ Mud ☐ Sludge ☐ Debris ☐ Grease  
Silt Depth: (in.) Deposits Extent:  
Infiltration: **Evidence** Pipe Seal Cond: **Broken**

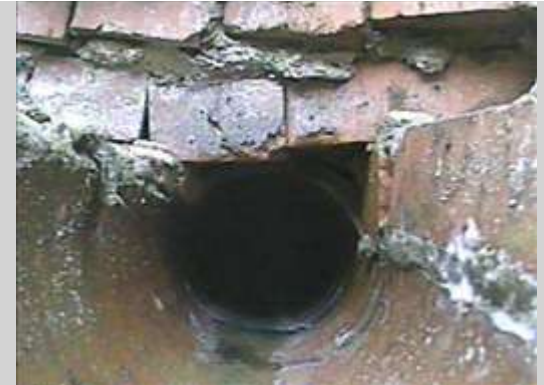
12 O'Clock Outflow

6 in. Circular Gravity Sewer  
Pipe Out @ 12 O'Clock

CHANNEL DETERIORATION

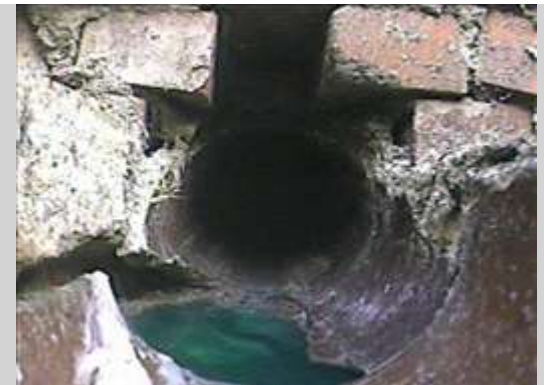
6 O'Clock Inflow

CHANNEL DETERIORATION
